## CASE HISTORIES

The Waterwise Aerator range has been patented by Jack David Collins.

From the year 2012 Waterwise Aerators were installed though Victoria and NSW on a site specific basis. The following selected sites are designed to supply information on the kind of problems experienced and how Waterwise **solved** these problems:

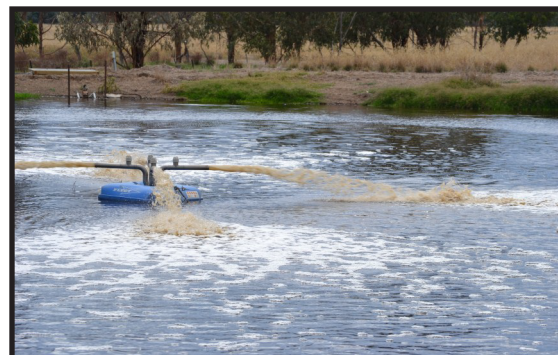
### CASE 1

- Install a Waterwise Aerator 5-9kW unit in pond. Within 5 days of installation the odour was completely removed and the odour has not returned since installation of the aerator

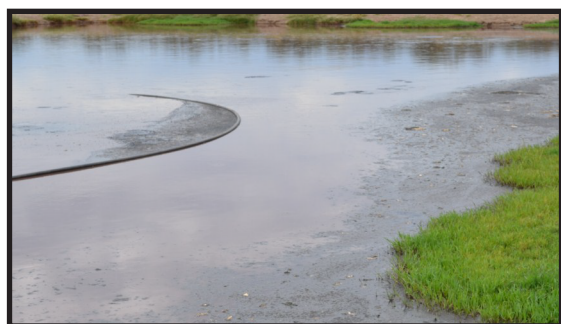
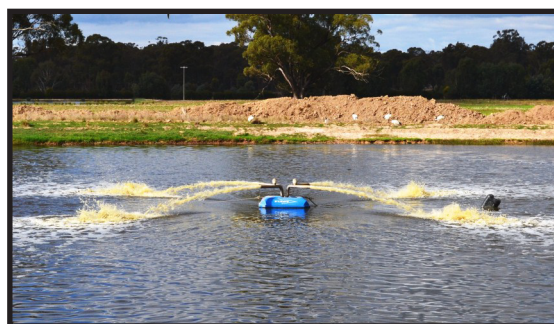
### CASE 2

- Install a Waterwise Aerator 3.1kW unit. Since the installation water quality has significantly improved and no odours have been detected. EPA has reissued the abattoir's licence to discharge for 2013.

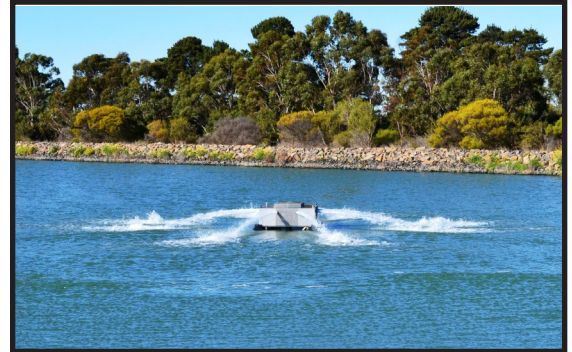
### CASE 3

- Install a Waterwise Aerator 5.9kW unit. Since the Waterwise Aerator has been installed the Blue-Green Algae count has fallen from 1.2 million cells per litre to 0-342 per litre and holding for the 3 months at a time of the year when algal blooms proliferate. In operation since 2012.

The results in the case histories involving odour control and improved discharges were no surprise, however the removal of the Blue Green algae at the storage dam for Western Water and the partial mix configuration for facultative lagoons at Lower Murray Water was an additional benefit. Add these performance levels mentioned in the case histories to the low power cost and negligible maintenance costs and you have a system of treatment that has unlimited possibilities.

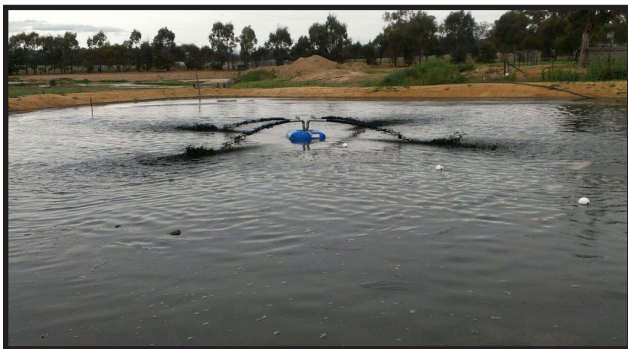
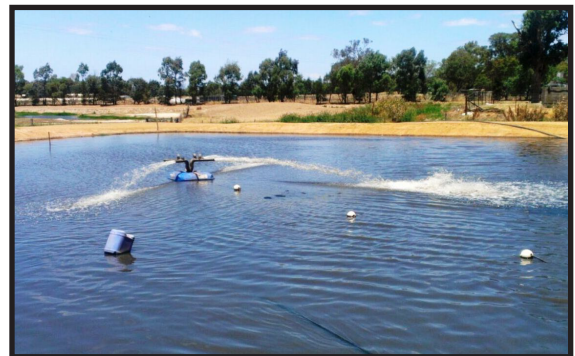
### CASE 4

- Install a Waterwise Aerator 3.1kW unit. Result, odour removed within 5 days of installation and BOD's fell from 893mg/L to 34mg/L - Suspended Solids fell from 20,000mg/L to 311mg/L within a 6 week period. EPA licence secured.

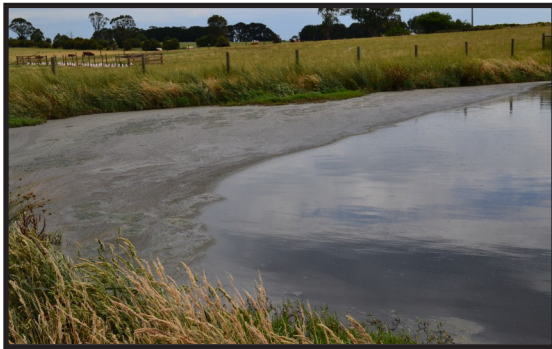
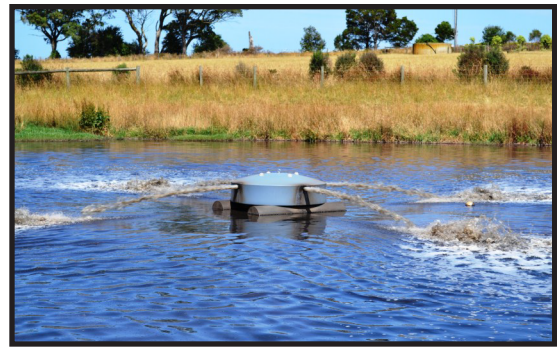
## CASE 5

- Install a Waterwise Aerator 3.1kW, installed in November 2012. No odours detected since the installation
- Surface sludge eliminated
- EPA Approved

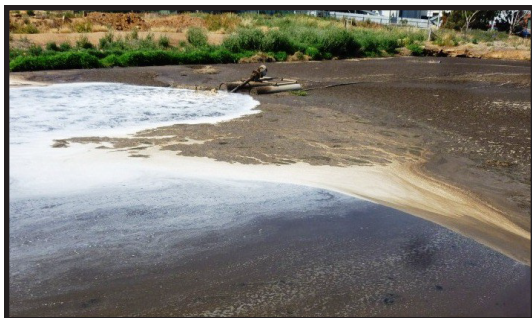
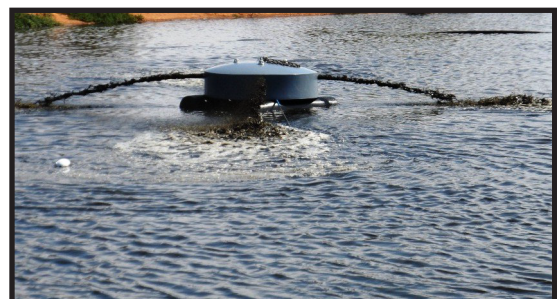
## CASE 6

- Install a Waterwise Aerator 3.1kW with chopper pump impeller (new internal design) installed in November 2012.  
No odours detected, sludge build up eliminated.

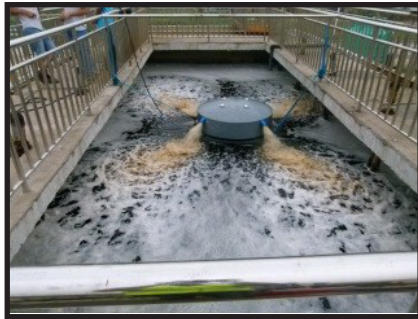
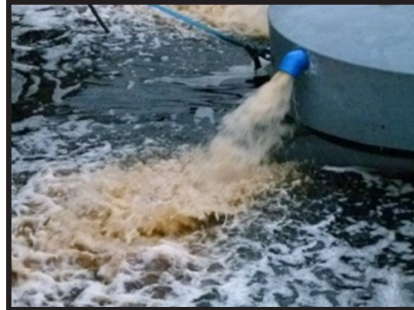
## CASE 7

Challenge: The site receives domestic waste to 2 holding ponds. Pond 1 is a underground concrete pond and pond 2 is an above concrete pond with one small, narrow opening.

- Install 2 x 3.1kW Waterwise Aerators one in each pond. Unit installed in pond 2 was fitted with 45 degree bends to compensate for the narrow basin.
- No odours detected since the installation, Water quality has significantly improved and power consumption reduced
- Played a major role in complementing additional treatment processes in performing more efficiently and effectively

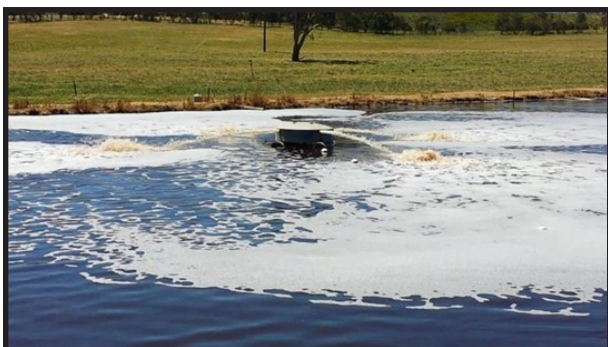
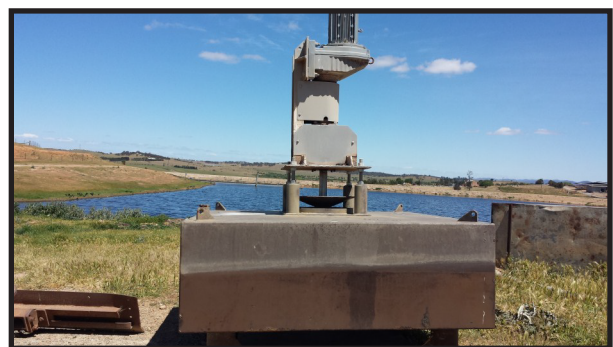
## CASE 8

- Install a Waterwise Aerator 4.7kW system with chopper impeller
- BOD's and TSS have significantly reduced
- Power consumption has significantly reduced
- No odour detected

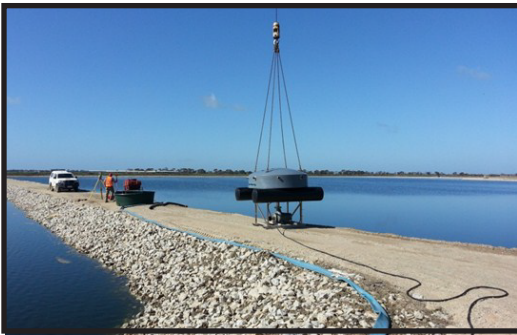
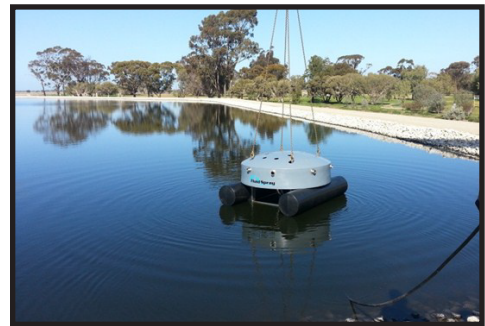
## CASE 9

- 5.9kW Waterwise Aerator was installed in a partial mix configuration, with an inlet draft tube directed towards the surface to reduce the destabilization of settled sludge and avoid macroscopic admixing between the anaerobic and aerobic zones. High strength wastewater is kept in the anaerobic zone while the aerobic zone is enlarged, supporting the growth, accumulation and generation of additional aerobic bacteria that intercept and convert toxic and odorous compounds into those that are olfactory inoffensive and safe.
- No odour has been detected since the installation, facultative lagoon has maintained an equilibrium.

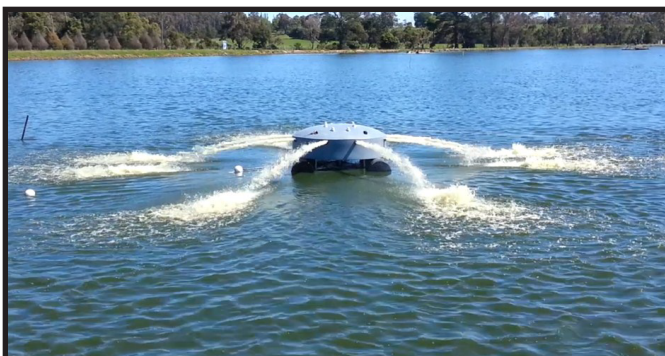
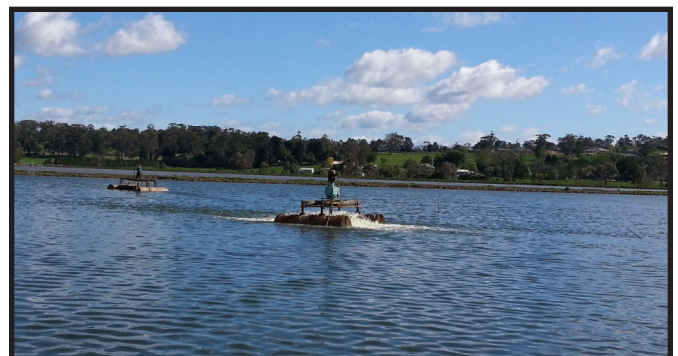
## CASE 10

- Install a 5.9kW Waterwise Aerator fitted with a chopper impeller.
- Reduction in Ammonia - Confirmed

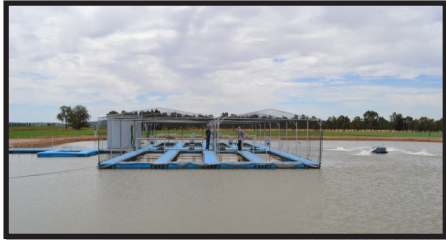
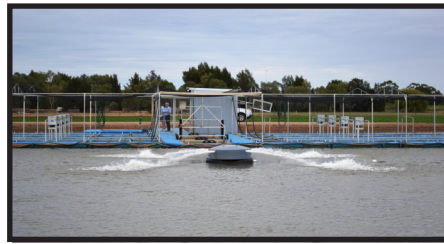
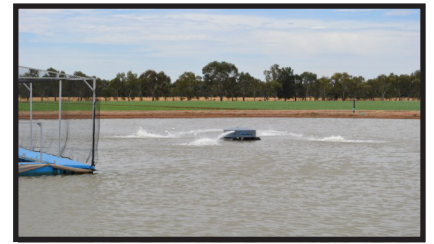
## **CASE 11**

- Install a 3.1kW Waterwise Aerator fitted with a suction screen

A Waterwise Aerator 3-1kW was installed in a fish farm in N.S.W Australia to remediate the very low Dissolved Oxygen (D.O.) levels in the breeding ponds. The D.O. levels were down in the low 2.s which is stressful for fish in intensive breeding programs. Within 4 days of installation the D.O. levels rose to 9 in the afternoon and 5-6 in the mornings. The D.O. levels normally drop of a night time. The pond is approx. 75 metres x75 by 5 to 6 metres deep giving a capacity of approximately 12 megaliters mega- litres. The company is exceptionally happy with the results now that the low oxygen problems have been solved. Each module in the pond carries 20,000 fish. The company will now install another breeding module in that pond which will double the production ability.
